TITLE: Ejection-Seat-Quick-Release-Fitting Quantitative Fractography and Estimation of the Local Toughness using the Topography of the Fracture Surface

TITLE: New Frontiers in Integrated Diagnostics and Prognostics.
Proceedings of the 55th Meeting of the Society for Machinery Failure
Prevention Technology. Virginia Beach, Virginia, April 2 - 5, 2001

Ejection-Seat-Quick-Release-Fitting
Quantitative fractography and estimation of the local toughness using the
topography of the fracture surface

K.Wolf, Bundeswehr Research Institute for Materials, Explosives,
Fuels and Lubricants (WIWEB)
Landshuter Str. 70, 85435 Erding, Germany

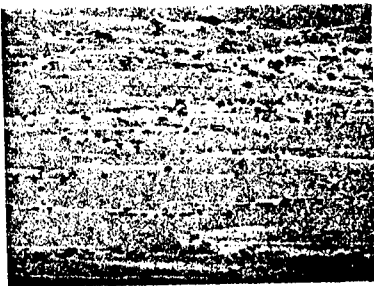
Metallographic samples were taken through the cross-section of the fracture origin on „S“, „N“ and „V8“. The cleanliness of the material was relatively good for the required alloy, despite of only few inclusions, but „N“ showed many precipitates and bands (Figures 5 and 6). Microhardness measurements were performed on cross-sections of these parts. The required hardness as specified on the governing engineering drawing

Figure 5 200:1
Micrograph of a cross-sectional microstructure with only few precipitations - bell S

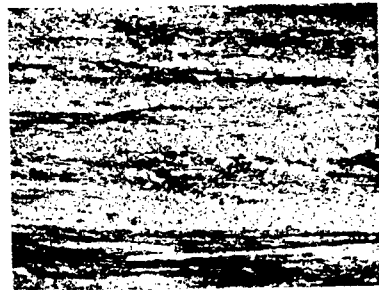
Figure 6 200:1
Micrograph of a cross section of the new bell N with numerous precipitations and distinct grains

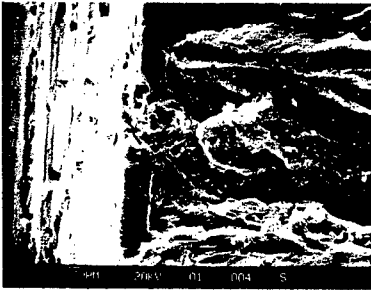
The fatigue fracture surface of the broken bell and the cracked bells were examined with respect to the striations at the origin area, the middle area and the crack tip area to quantify the crack propagation. Figure 11 shows the measured values (striations per mm) as a function of the crack length. These values were calculated by regression to get an average curve [1;2;3]. The integration of this curve lead to the crack propagation curve (Figure 12). The comparison of the derivated crack propagation (dl/dN) of the striation width with literature values shows that the crack propagation was uncritical at most investigated bells (Figure 13). This lead to the conclusion that for cracked bells even with relatively long cracks no critical stage can be expected during the time fixed life span,

Figure 9
SEM-micrograph of the crack area with striations – bell S

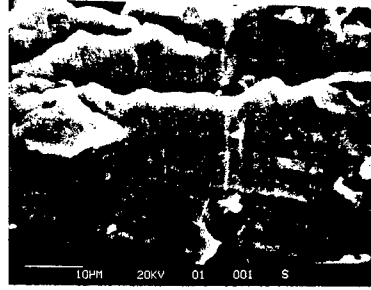
The bells „V1“ to „V8“ showed precrack extensions from 0.4 mm to 1.5 mm whereby the plate thickness was 1.5 mm. The circumference precrack extension runs from 4.5 mm up to 26 mm. Only „V4“ and „V8“ showed precracks on both sides (up to 0.3 mm). The longest precrack was found at „V7“ (26 mm). The results of the SEM-investigation showed that „S“ and „V1“ to „V8“ cracked due to fatigue fracture (Figure 9). The fatigue crack on „S“ was initiated by etch-pits and pittings underneath the 10 μm eloxal layer (Figure 10). The crack propagation took place from the outside of „S“. The crack propagation showed in addition to the operational load marks signs which points to the load of the bell during „put on-lock-take off“. Because of this operation the mass of the solid central part moves away from the mid part of the bell. Due to this loading the mid part is overcome by bending. The pits and pittings promoted the precracks in this area.

Figure 10
SEM-micrograph showing preinduced crack area with a crack origin underneath the eloxal layer – bell S
